## ASBESTOS RE-INSPECTION SURVEY REPORT

WAREHOUSE 2  
GSA BUILDING NUMBER WA0825KF  
2703 C STREET SW  
AUBURN, WASHINGTON

ASSESSMENT DATE:  
09-14- 2012

PREPARED BY:  
UNITED STATES PUBLIC HEALTH SERVICE  
FEDERAL OCCUPATIONAL HEALTH SERVICE  
DALLAS AREA OFFICE  
1301 YOUNG STREET, SUITE 772  
DALLAS, TX 75202

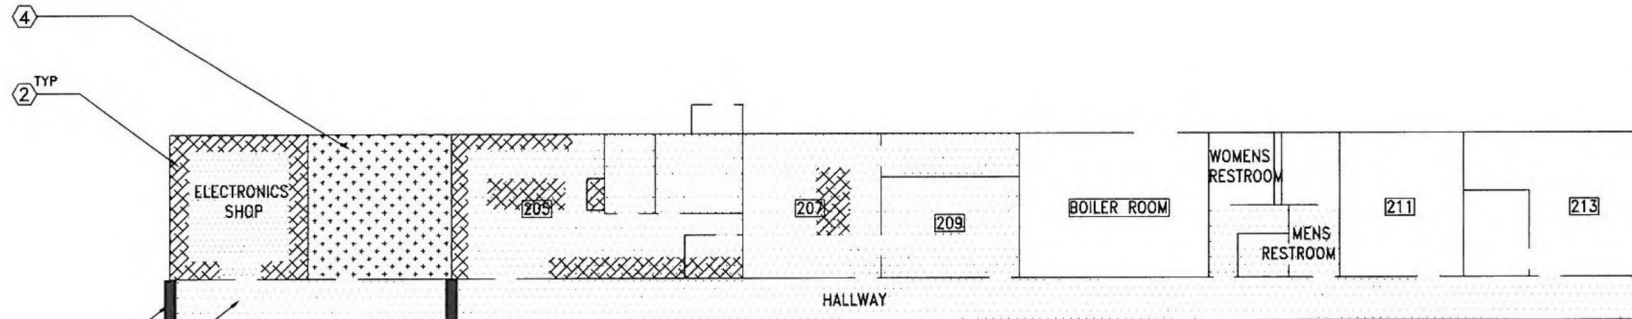
- ① ASBESTOS CONTAINING CORE FIREDOOR
- ② BLACK ASBESTOS CONTAINING COUNTERTOP
- ③ VINYL ASBESTOS TILE WITH ASBESTOS CONTAINING MASTIC
- ④ CARPET OVER VINYL ASBESTOS TILE WITH ASBESTOS CONTAINING MASTIC

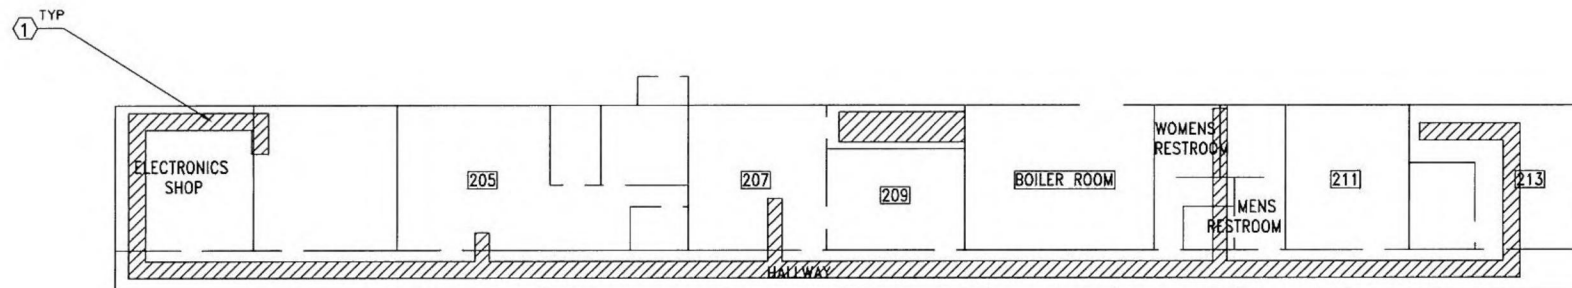
HM - 2.0

- ① ASBESTOS CONTAINING TSI PIPING (INCLUDES FITTINGS)

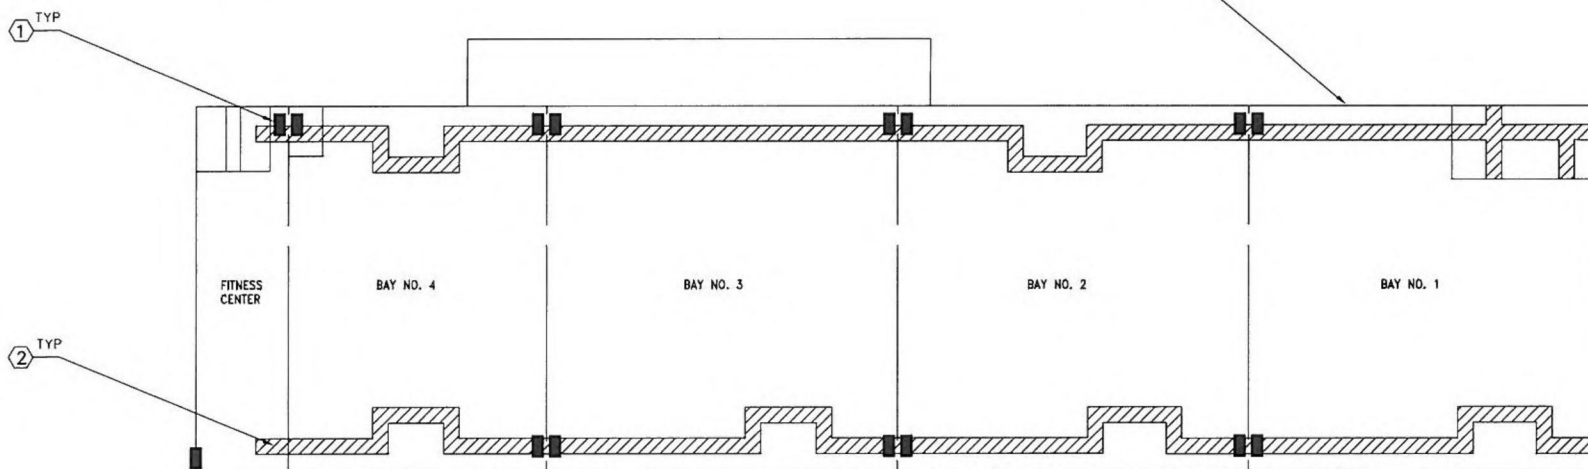
- ① ASBESTOS CONTAINING CORE FIRE DOORS. INTERNAL FIRE DOORS SEPERATE BAYS AND ARE APPROXIMATELY 10' X 20' EACH.
- ② ASBESTOS CONTAINING TSI PIPING (INCLUDES FITTINGS)
- ③ CEMENT ASBESTOS BOARD ON EXTERIOR SOFFIT AND ASSUMED ASSOCIATED FELT VAPOR BARRIER PAPER
- ④ CEMENT ASBESTOS BOARD ON INTERIOR WALL PANEL LINING OF SPRINKLER CONTROL HOUSINGS
